Franklin Elementary

Lakeview Elementary

Foster Elementary

Middle School

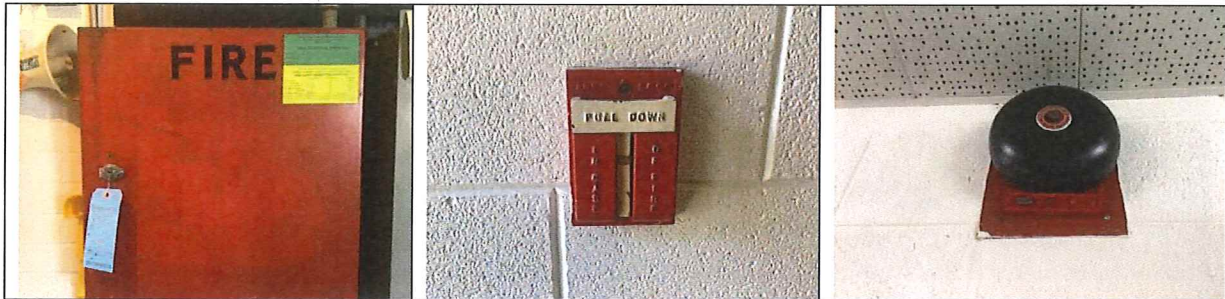
- a. The fire alarm system is original to building. The equipment appears to be in working condition but is at the end of their life expectancy and does not meet current code requirements. A new fire alarm system with voice evacuation will be required for a renovation.

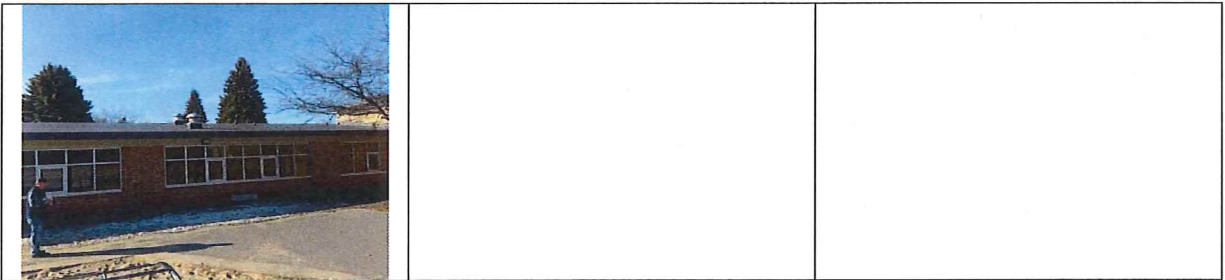
1. Air handling systems
 - a. There are a number of exhaust fans on the roof that would likely be replaced with new or be removed with a new system design.

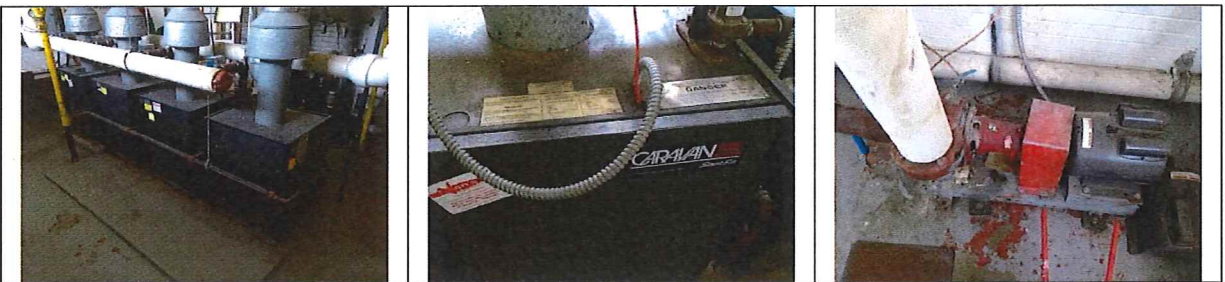
2. Central plant systems
 - a. Hot water boilers (4) built in 1996 should be replaced with new high efficiency boilers.
 - b. Older hot water pumps should be replaced with the addition of VFDs.
 - c. No cooling in building.

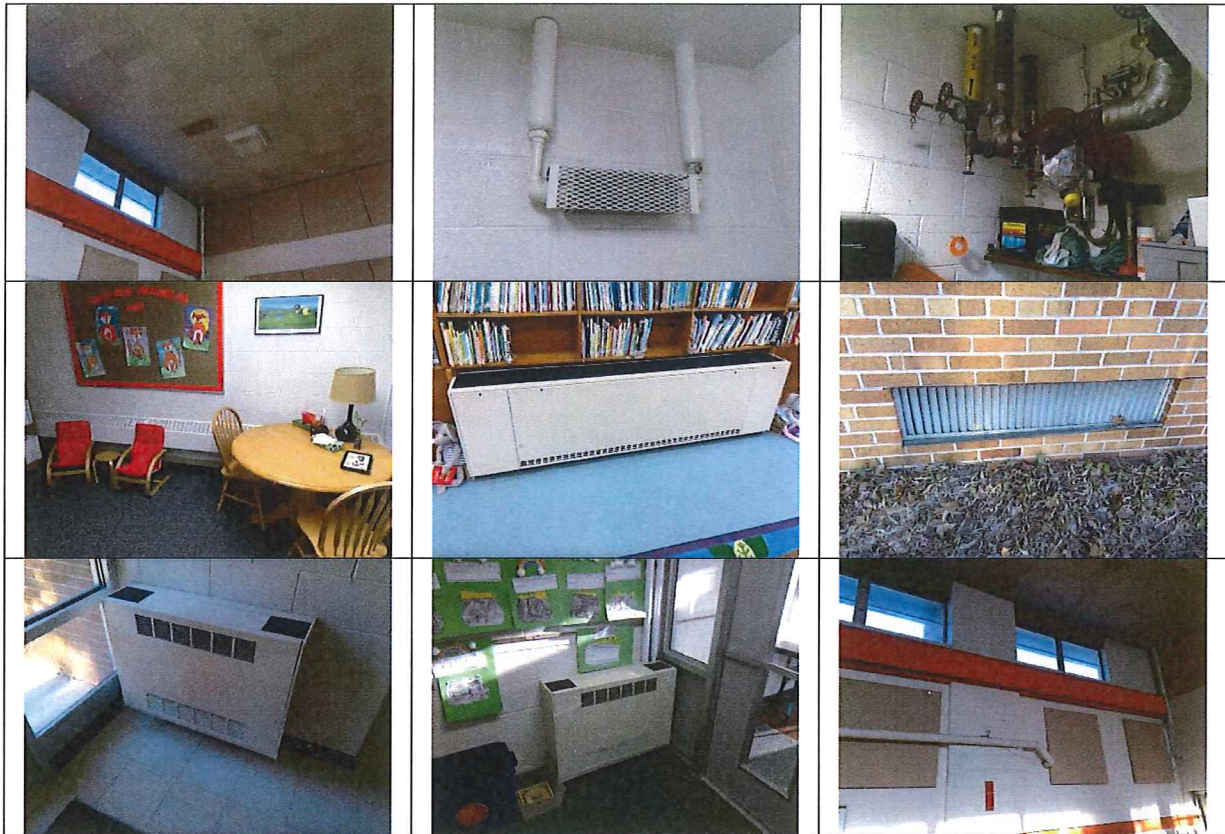
3. Terminal devices and air terminals
 - a. Cabinet heaters and horizontal unit ventilators throughout are older and in fair condition.
 - b. Consider replacing horizontal unit ventilators with vertical unit ventilators in classrooms and add cooling.

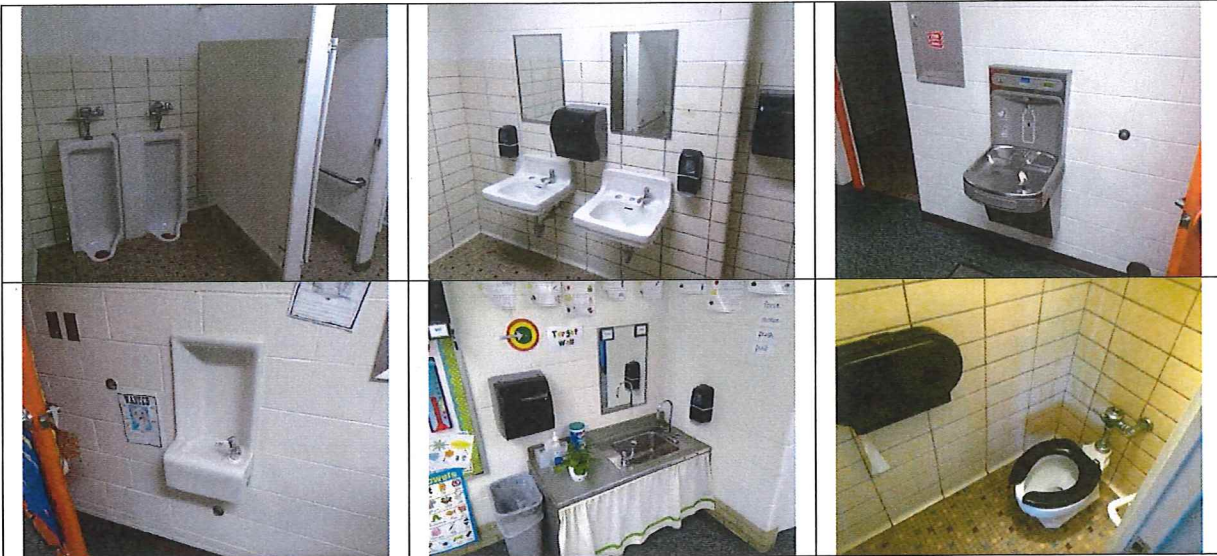
- a. Mix of plumbing fixture types and condition throughout. Older fixtures should be replaced.
- b. Manual flush valves.

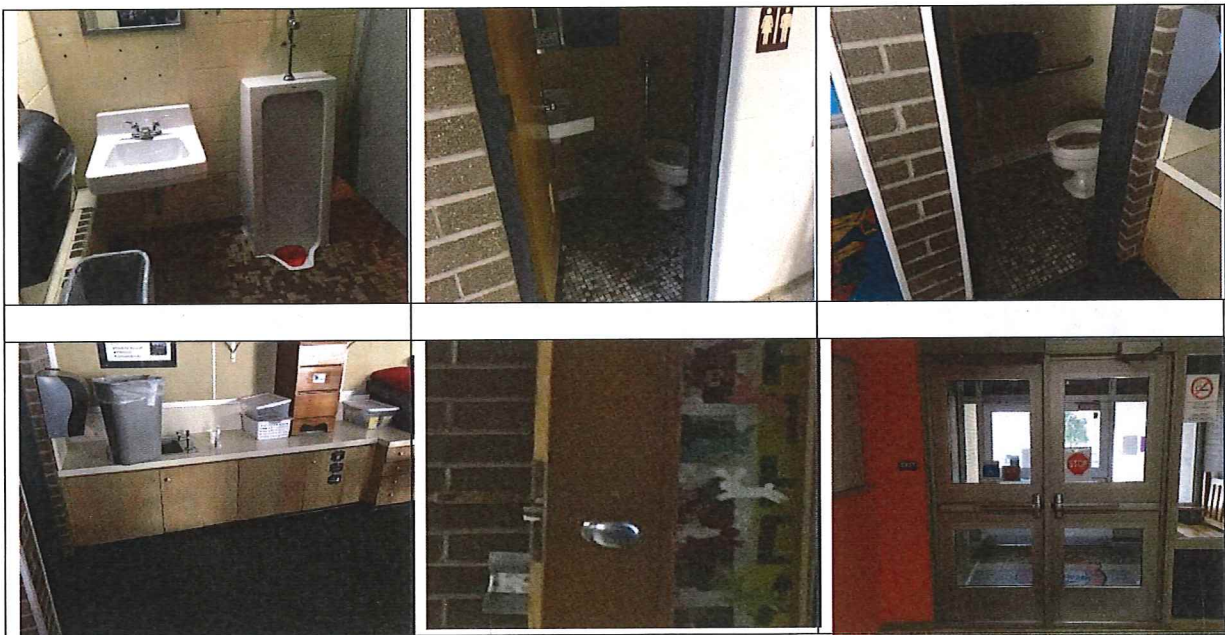
1. Interior
 - a. None of the bathrooms observed in the building are ADA compliant, including sinks, water closets, toilet compartments, maneuvering clearances, accessories and door hardware. This is inclusive of the single occupant toilets and the gang bathrooms. All would require a complete reconstruction to meet current code requirements.
 - b. The classroom sinks appear to allow for a side approach to meet code requirements.
 - c. Knob type locksets noted throughout the building which does not meet current code requirements.
 - d. An auto operator was noted at the main entrance.
 - e. The raised platform in adjacent to the multi-purpose room is not accessible. A ramp or lift is needed to bring it into compliance.
 - f. There is no ADA access to the upper floor. A passenger elevator is recommended to provide adequate ADA access.

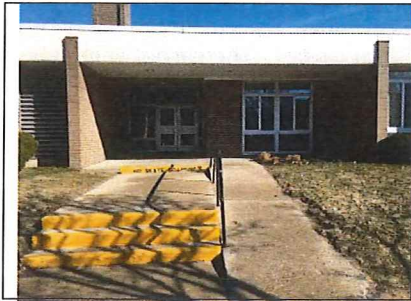
- a. There is not adequate ADA parking with an accessible route to the building.
- b. The ramp to main entrance is not compliant.
- c. There is no clear pathway from the parking to the building entrance, ADA or otherwise.
- d. The concrete walks to the building are in fair conditions to poor condition.

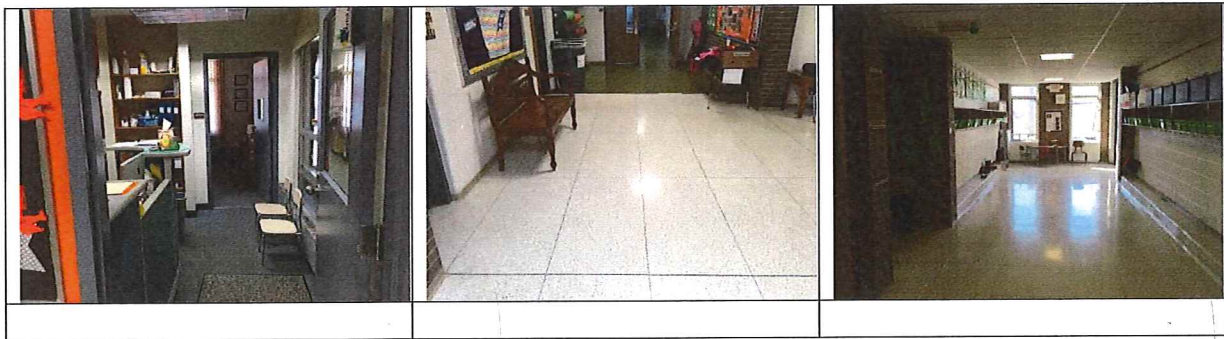
1. Flooring
 - a. Terrazzo
 - i. Located primarily in the corridors, on both floors, along with the 2nd floor bathrooms. It is generally in good condition.

- b. Carpet
 - i. The classrooms and media center flooring is broadloom carpet. The carpet is in poor condition, worn in the high traffic areas, with some fraying and buckling evident. Recommend that it all be replaced.

- c. Ceramic Tile
 - i. The restroom flooring on the first floor and in the classrooms is 1"x1" ceramic tile. It is stained and has been patched at some locations. Removed and replaced as part of a restroom reconstruction.

- d. Vinyl Composite tile
 - i. Noted in the kitchen. In fair condition with the exception of areas adjacent to the exterior door which are failing.
 - e. Resin coated

- f. Note that the floor tile in the art/music room appears is 9x9 which generally denotes it is an asbestos containing product. Remediation recommended.

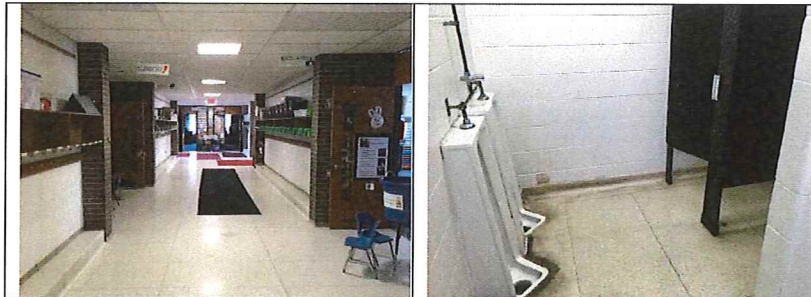
- a. Painted CMU walls are in fair to poor condition. There was many areas of peeling and discolored paint noted.
- b. Exposed brick walls are in good conditions.
- c. Gypsum board walls in the office area are in fair condition.

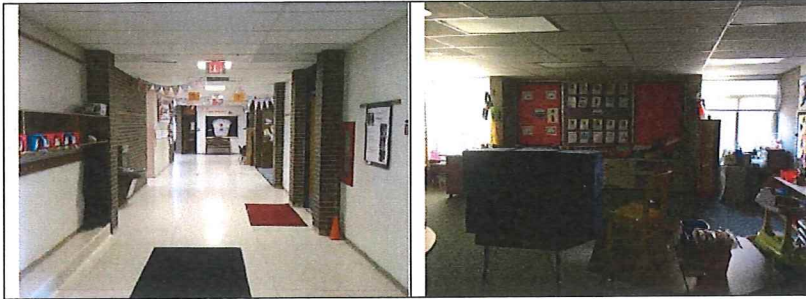
- a. 2'x4'suspended acoustical ceilings
 - i. The corridors are in poor condition and should be replaced. Ceiling tile is mismatched, damaged, and stained. Parts of the grid are damaged and rusting.
 - ii. The classrooms are in poor condition and should be replaced. Ceiling tile and grid are mismatched, damaged, and stained
- b. Painted hard lid ceiling
 - i. The painted hard lid ceilings and bulkheads are in fair condition.
- c. Exposed
 - i. The exposed metal deck in the multi-purpose room and storage rooms are in good condition.

- d. The direct applied acoustical
 - i. The direct applied acoustical ceiling s in the restrooms are faded and stained.
Replaced as part of the restroom reconstruction.

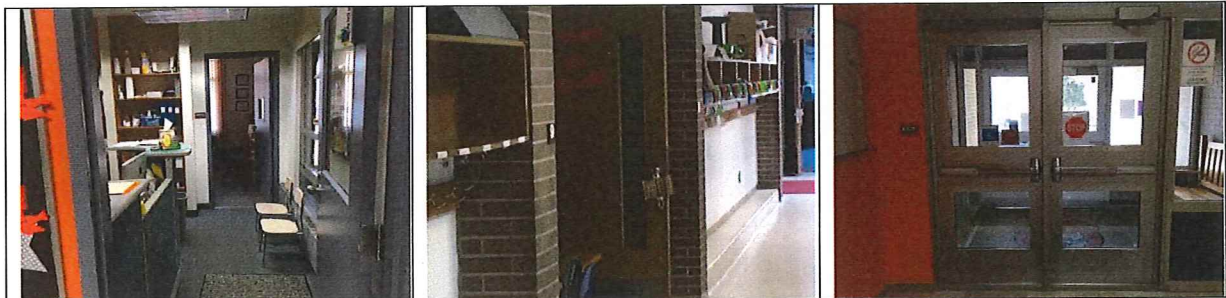
- 4. Doors and Hardware
 - a. The doors and hardware are in fair to poor condition, with the exception of
 - b. The locksets are of a non-compliant knob type.
 - c. The corridor doors, frames, hardware, and glazing are not compliant with current fire code and ADA standards.

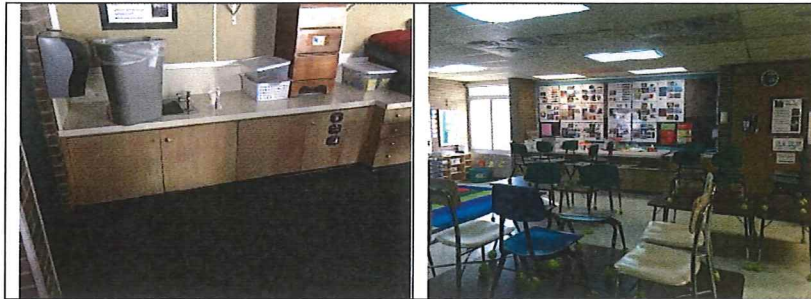
- a. The classroom casework is limited to lowers cabinets and open shelving,
- b. The casework and counters are worn, damaged, missing hardware and showing signs of heavy wear. Recommend they be replaced to maximize classroom storage and efficiency.

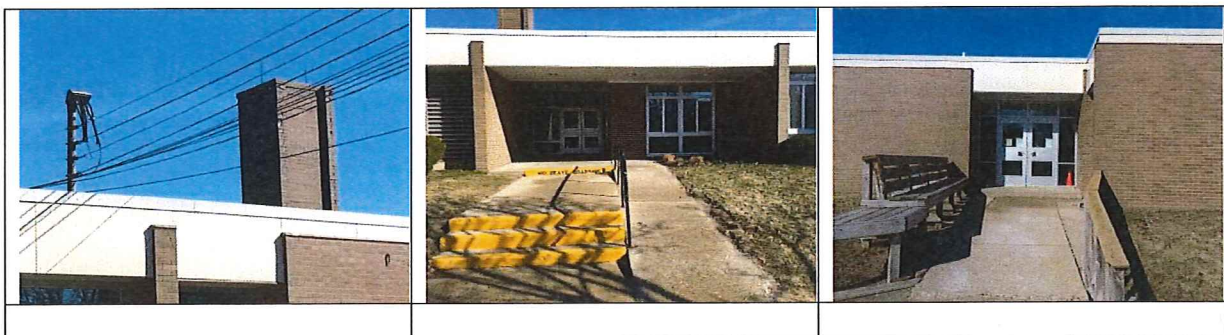
1. Brick
 - a. The brick is generally in good condition. General maintenance recommended at control joints and around imbedded items to maintain integrity of the caulk joints.

- b. Light damage noted at a few locations.
 - c. The chimney is in poor condition with visible signs of brick failure. Recommend it be partial rebuilt or removed.

2. Soffit and fascia
 - a. Metal panel fascia in fair to poor conditions. The finish is faded and chipped. Rust is present at many locations.
 - b. The perimeter sealant at metal panels has failed and needs to be removed and replaced.

- c. The soffit material is cementitious, possible transite. Most of the joint sealant has failed. Many of the fasteners have started popping and some of the panels are starting to sag. Recommend removal and replacement.

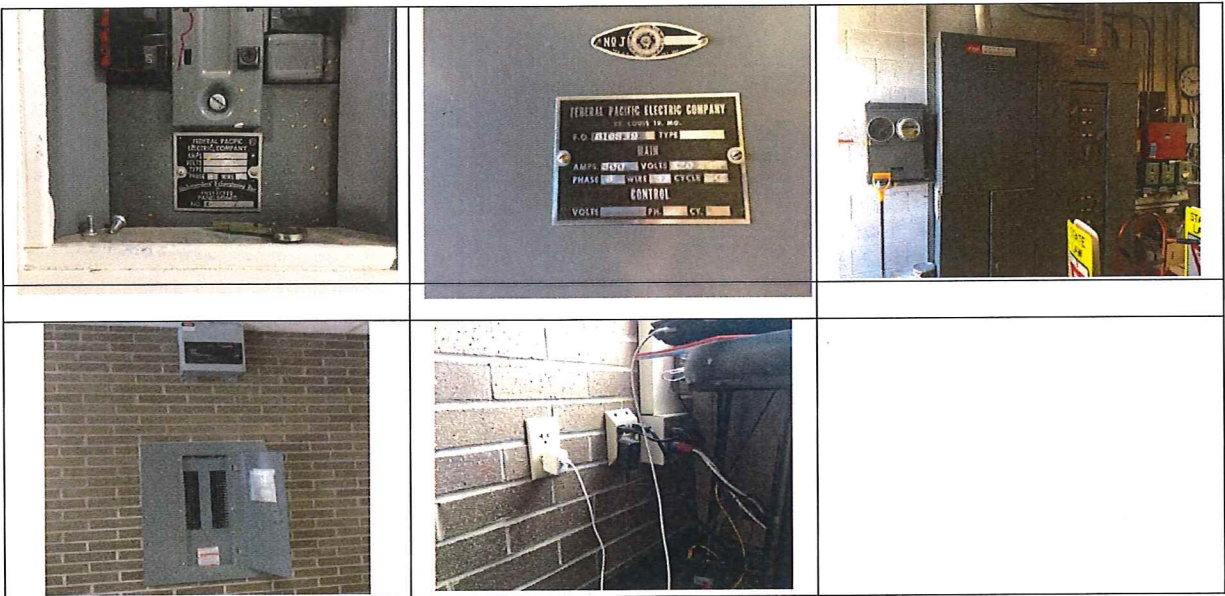
1. Electrical distribution system
 - a. Electrical distribution system is original to building including switchboard and panelboards. The equipment appears to be in good working condition but is at the end of their life expectancy. A new electrical distribution system is recommended to be installed with renovations.
 - b. To comply with current electrical safety standards a fault current and arc flash study should be completed to evaluate the electrical equipment's ratings, required personal protective equipment and install proper warning labeling.
 - c. General receptacle locations are limited in classrooms and other areas. Multiple examples of power strips and devices on floors. Renovation should include new receptacle and power requirements to support uses.

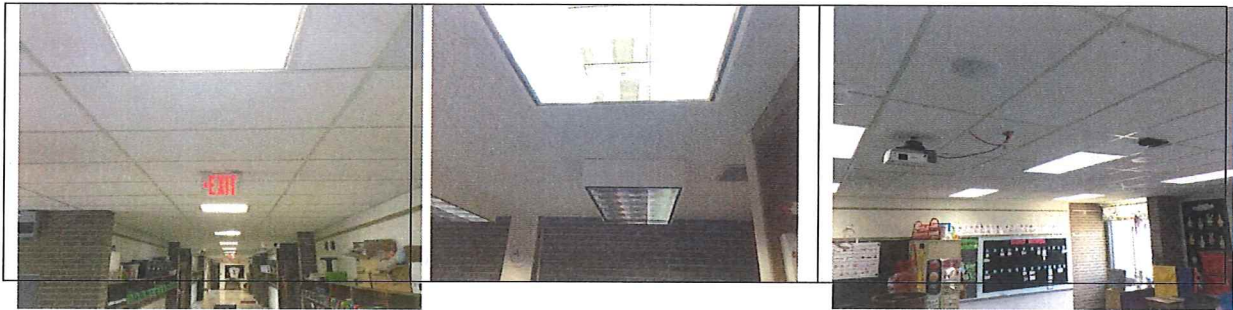
2. Lighting system
 - a. Interior lighting systems are predominantly T-12 fluorescent technology in the classrooms, corridors, offices and support spaces. T-8 fluorescent technology is installed in most corridors and is reasonably efficient. A cost benefit analysis is recommended for T-8 fluorescent against LED lighting. For other fixtures types (including HID and T-12 fluorescent) it is recommended these be replaced with LED lighting.

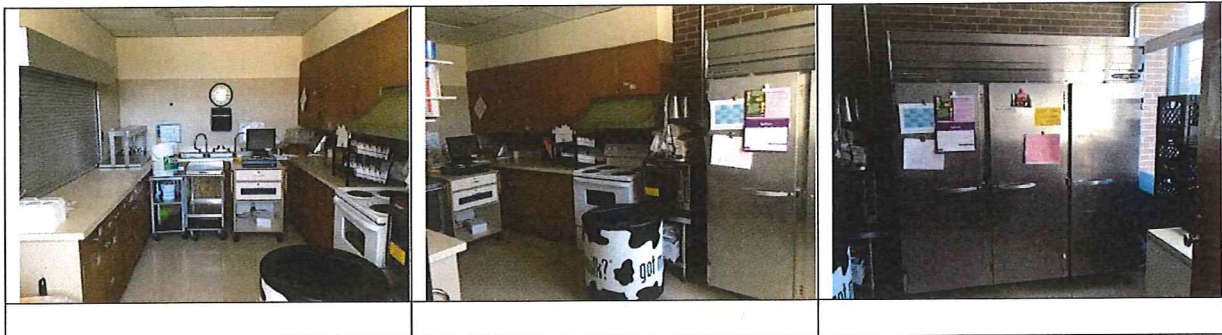
1. The kitchen is for warming and serving only. There is a single serving point through the East wall. Reconfiguring the serving area should be considered to increase flow and efficiency.
2. The kitchen equipment appears to be in good condition.
3. The VCT floor is in good condition.
4. There is a residential stove/oven along with a residential exhaust hood.
5. Unable to verify a grease interceptor associated with the 3 compartment sink.
6. Casework is of a residential type, in poor condition.
7. The acoustical ceiling does not appear to be of a washable type standard in kitchens. It is stained, discolored and mismatched.

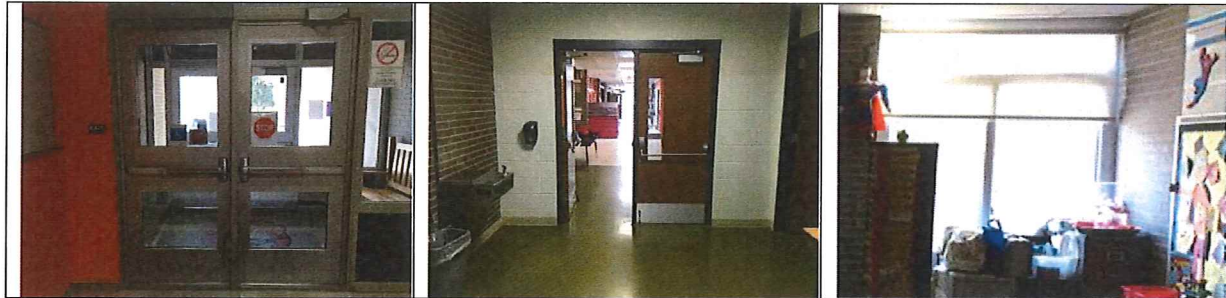
- a. The building does not appear to have a fire suppression system and is non-sprinkled, with the exception of the kiln room.
- b. The exit corridors have panic bars or crash bars that are in good condition.
- c. The classroom windows have emergency egress.
- d. Fire extinguishers cabinets observed throughout the building.

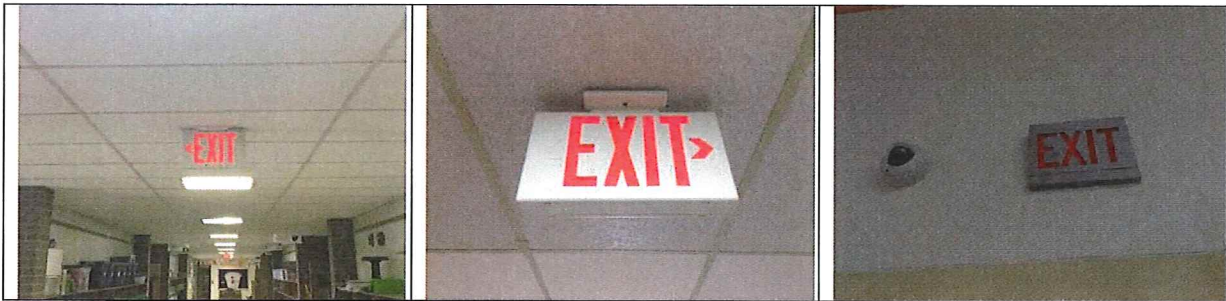
- a. Exit signs and emergency lighting appear to not be supplied by any emergency power source. To comply with current life safety code a building code evaluation would need to be completed and all new emergency lighting and exit signs installed. A new electrical generator system is recommended as a power source for emergency power.

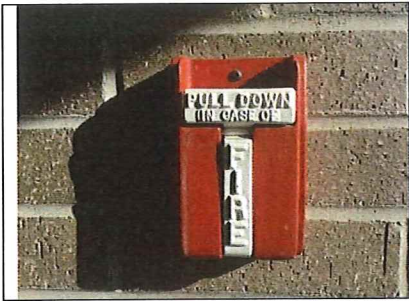
- a. The fire alarm system is original to building. The equipment appears to be in working condition but is at the end of their life expectancy and does not meet current code requirements. A new fire alarm system with voice evacuation will be required for a renovation.

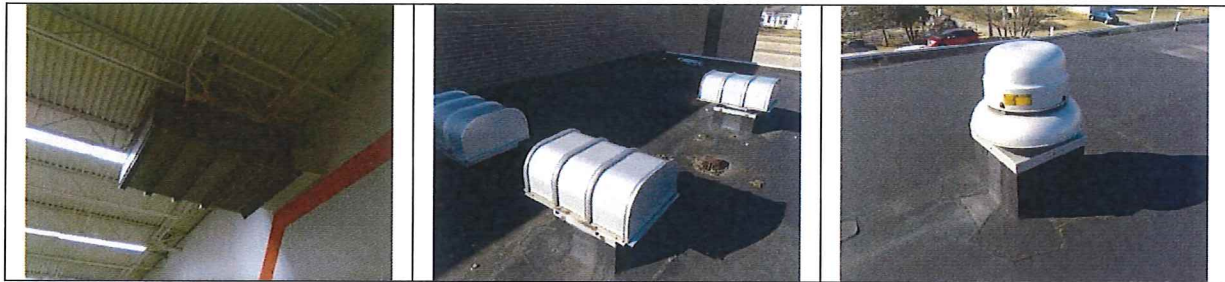
1. Air handling systems
 - a. Air handling units (2) in gym should be replaced with new.
 - b. Various hoods and exhaust fans on roof appear to be in fair condition.

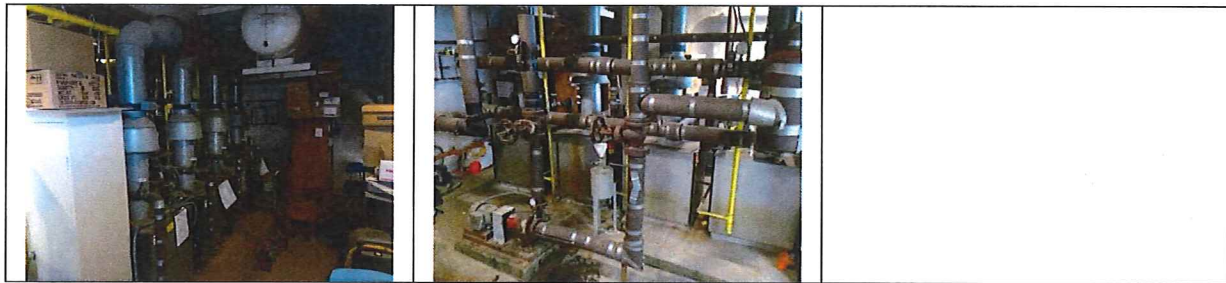
2. Central plant systems
 - a. Hot water boilers (4) built in 1989 should be replaced with new high efficiency boilers.
 - b. Older hot water pumps should be replaced with the addition of VFDs.
 - c. No cooling in building.

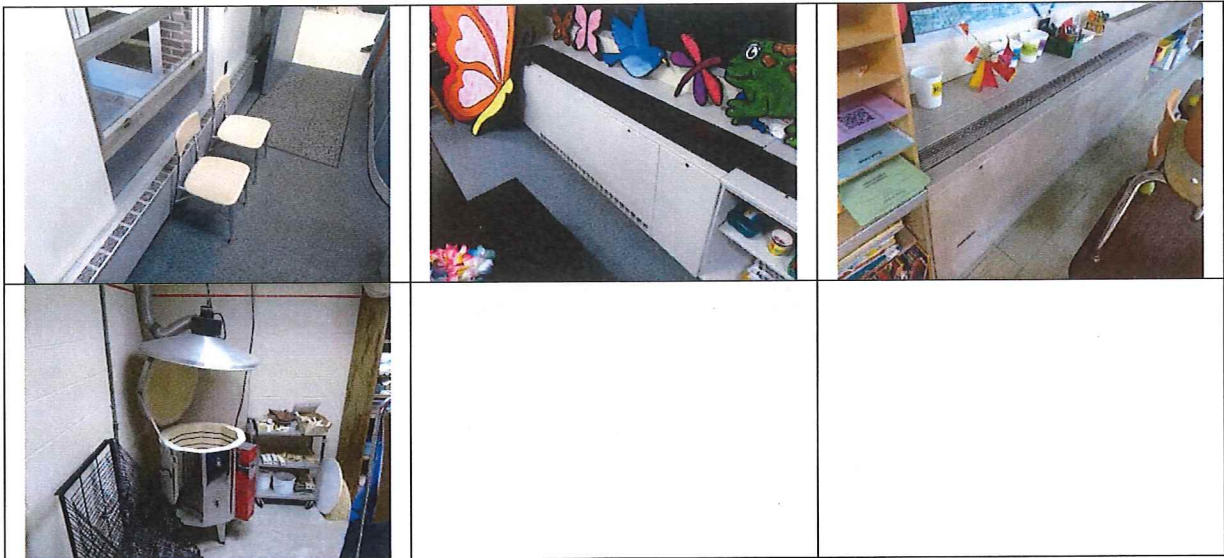
3. Terminal devices and air terminals
 - a. Cabinet heaters and horizontal unit ventilators throughout are older and in fair condition.
 - b. Consider replacing horizontal unit ventilators with vertical unit ventilators in classrooms and add cooling.

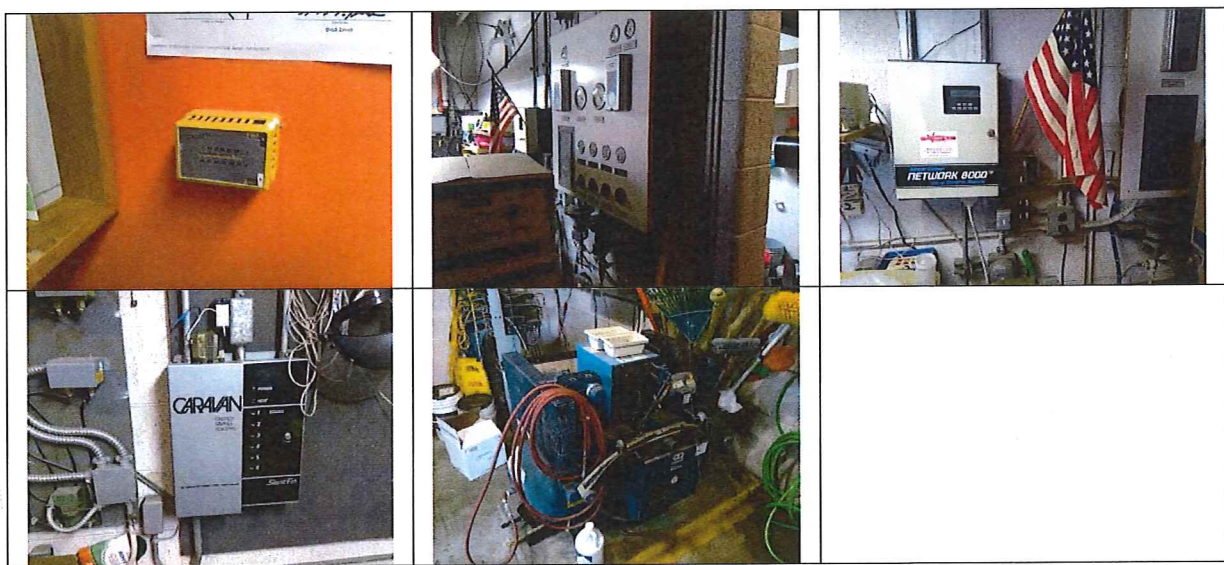
4. Building controls
 - a. Pneumatic controls should be replaced with new DDC system and new sensors throughout.

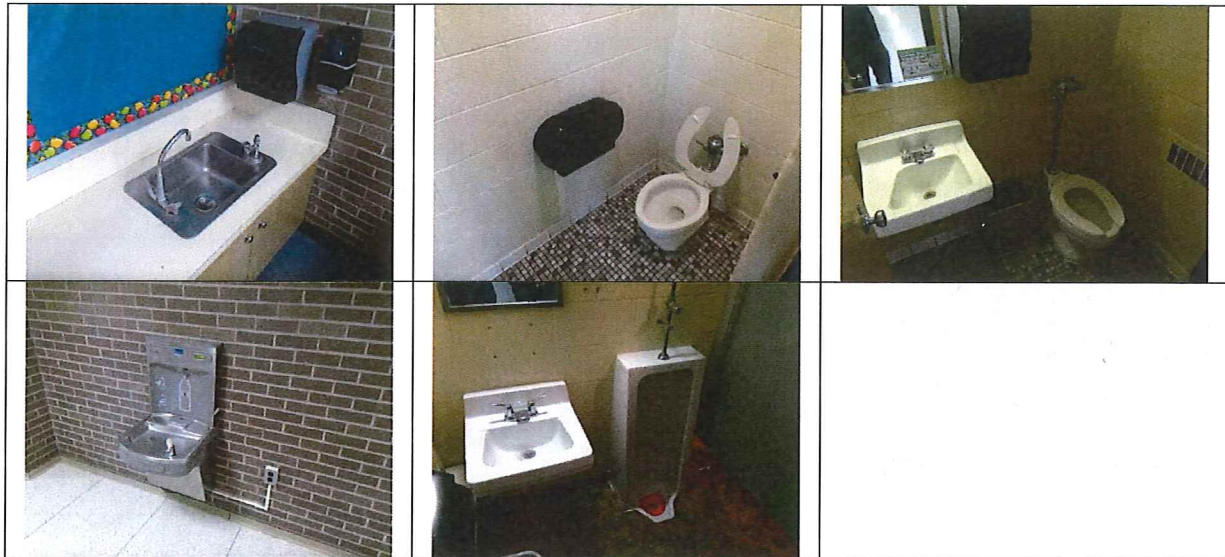
- a. Mix of plumbing fixture types and condition throughout. Older fixtures should be replaced.
- b. Manual flush valves.

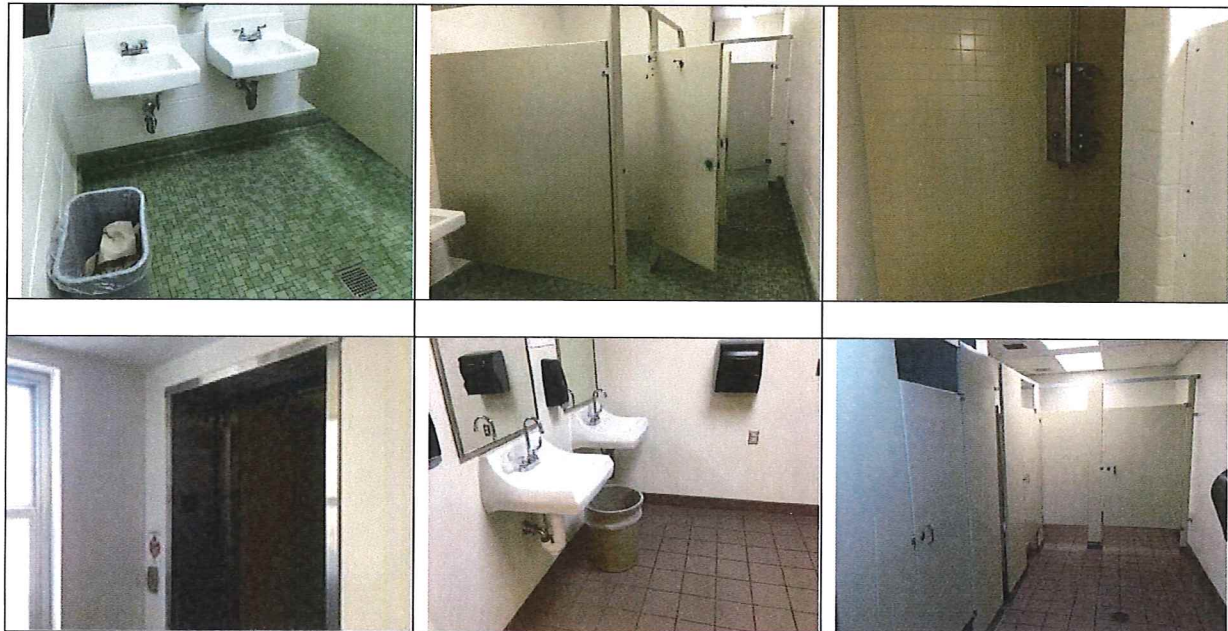
- f. There is an elevator that meets current ADA requirements.
 - g. Classroom sinks and hardware are compliant.
 - h. An auto door operator was not observed on the front entry doors or at the back parking lot area.

- i. The raised platform in the gymnasium is not compliant. A ramp or lift is needed to meet current requirements.

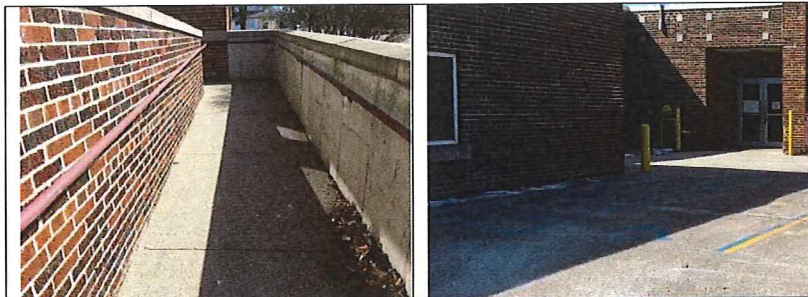
- a. There is very limited ADA parking and it is not clearly defined. One striped parking spot noted in a secondary entrance lot.
- b. No ADA signage noted.
- c. No tactile warning strips noted at curb cut downs.
- d. The ramp noted at the front entry exceeds the slope limits for ADA compliance.

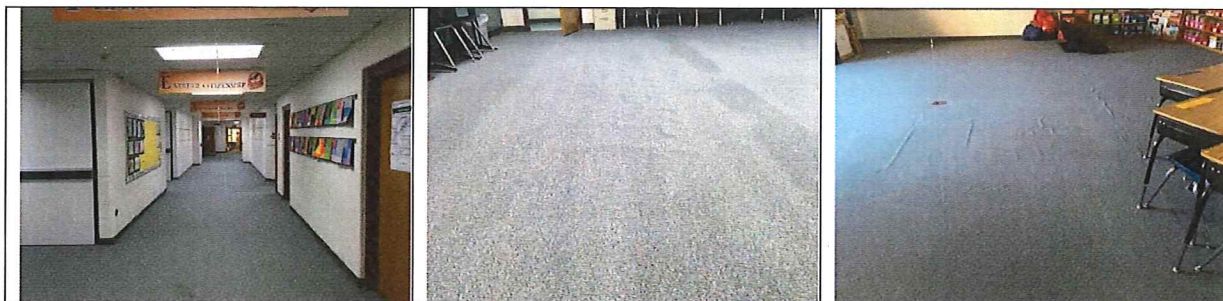
1. Flooring
 - a. Carpet
 - i. The Broadloom carpet observed in the first floor classrooms is in poor condition. The carpet is worn, frayed, and buckling. Recommend that it be replaced throughout the first floor classrooms.

- ii. The broadloom carpet on the second floor is in good condition.
 - iii. Broadloom carpet observed in the lower level corridors in fair to poor condition. The carpet is worn, stained, and buckling. Recommend it be replaced throughout the lower level corridors.

- b. Ceramic tile
 - i. There are varies types and sizes of tile noted in the restrooms and shower areas.
 - ii. The floor tile in the restrooms across from the gym in in poor condition. Multiple mismatched patches of the floor and base have taken place. Complete removal and replacement as part of a restroom reconstruction.

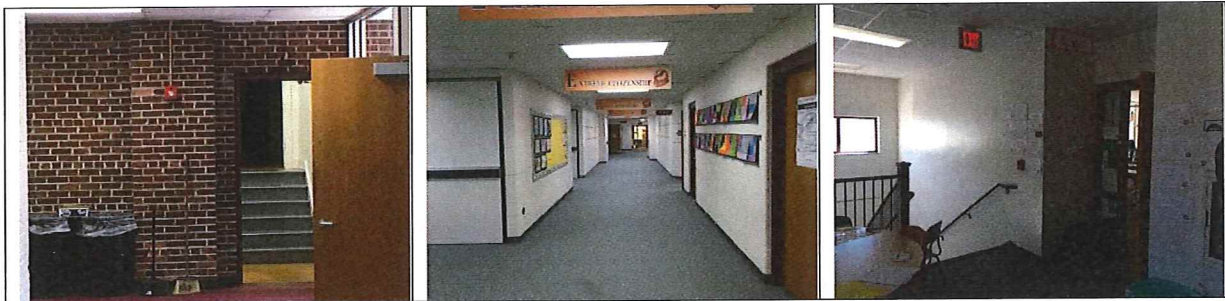
- a. The gymnasium walls are painted lazed block CMU, observed in fair to poor condition.
- b. The painted CMU walls are in good condition
- c. Exposed brick walls are in fair condition. General maintenance is needed to bring them into a good condition.
- d. The gypsum board walls noted on the upper floor are generally in good condition.

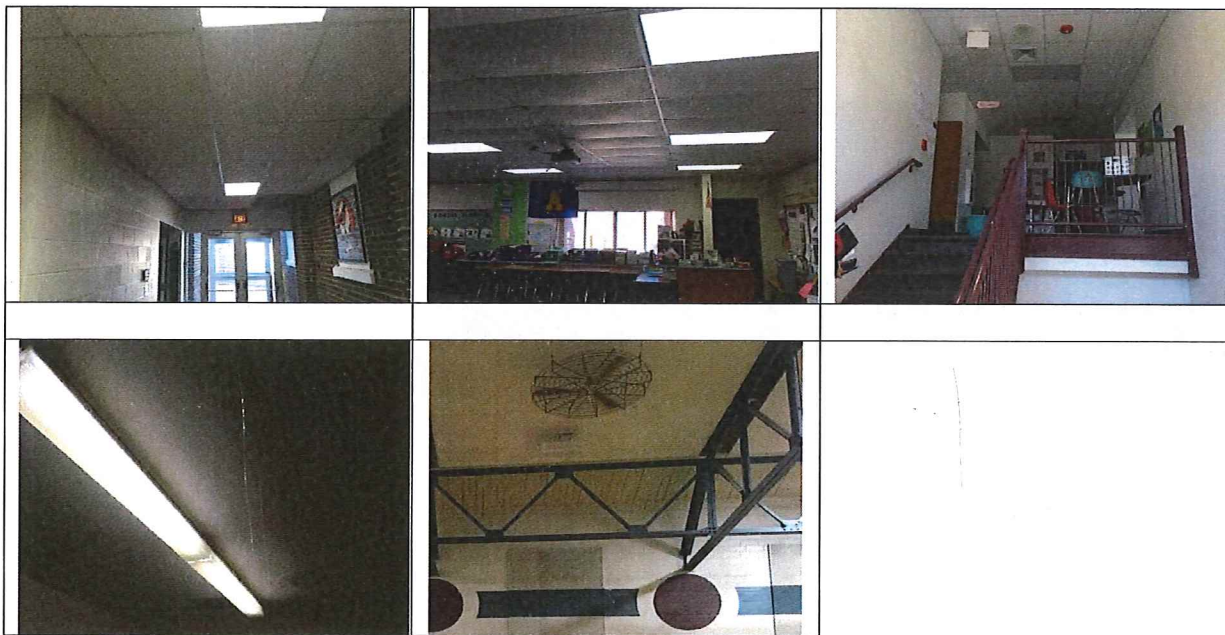
- a. 2'x4'suspended acoustical ceilings
 - i. The lower level corridors are in poor condition and should be replaced. Ceiling tile is mismatched, damaged, and stained. Parts of the grid are damaged and rusting. Recommend that it be replaced.

- ii. The lower level classrooms are in poor condition and should be replaced. Ceiling tile and grid are mismatched, damaged, and stained. Recommend it be replaced.

- iii. The upper level ceilings are in good condition.
 - iv. Media center ceilings are in fair condition, observed some damaged and curling ceiling tile.

- b. Painted hard lid ceiling
 - i. The painted hard lid ceilings range from fair to poor condition.
 - ii. Observed peeling paint and cracking, specifically in the restrooms across from the gym. Remove and replace as part of restroom reconstruction.

- c. Exposed
 - i. The exposed metal deck in the storage rooms are in good condition.
 - ii. The exposed wood decking observed in the gymnasium is in fair to poor condition.

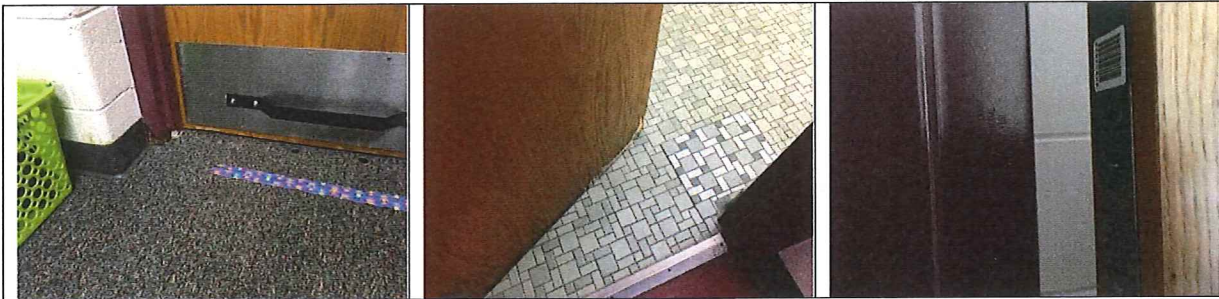
- a. The lower level classroom doors are fire rated and ADA compliant. The condition of the doors themselves is poor, with chipped edges, faded finish, and patched replaced hardware location.
- b. The classroom doors have lever type locksets and closures, observed in good condition.
- c. The corridor fire/smoke separation doors are in good condition, with the appropriate push bar hardware and magnetic hold open devices.
- d. The upper level doors, frames and hardware are compliant and in good condition.

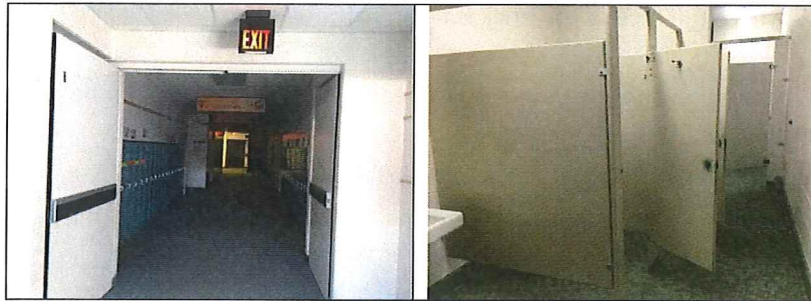
- a. There are built-in student lockers, observed in good to fair condition
- b. The classroom marker board and tackboards are in good condition.
- c. The toilet partitions vary in material types and conditions. The lower level partitions should be replaced and reconfigured.

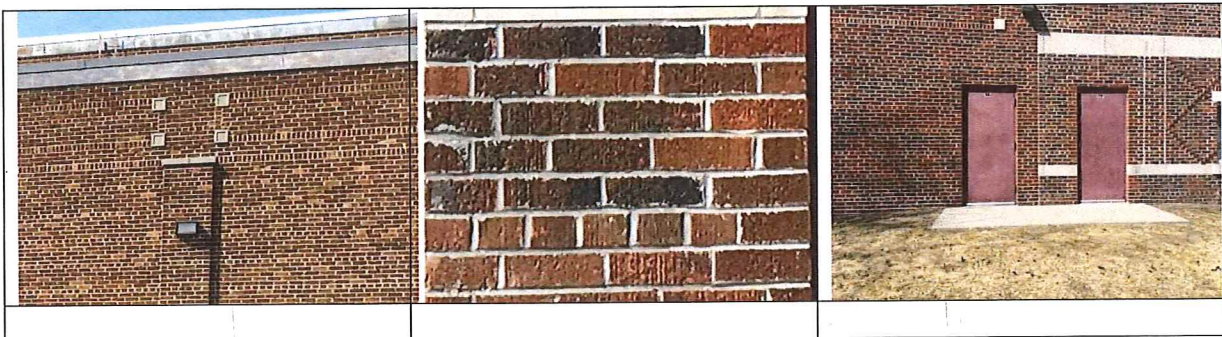
1. Brick
 - a. The condition of the brick ranges from good to poor, depending on age of construction.
 - b. Maintenance recommended at control joints and around imbedded items to maintain integrity of the caulk joints.

- c. Observed some locations where the face of the brick is flaking off.
2. Soffit and fascia
 - a. The stone fascia is in poor condition and showing signs of heavy wear. Recommend it be removed and replaced or rehabilitated.

- d. The exterior hollow metal doors and frames are starting to show signs of rust. Recommend they be replaced with aluminum or FRP.
4. Roofing
 - a. There are immediate needs for new roofing above the upper level. The coated, rolled roofing is failing at the parapet walls and is open for water infiltration.

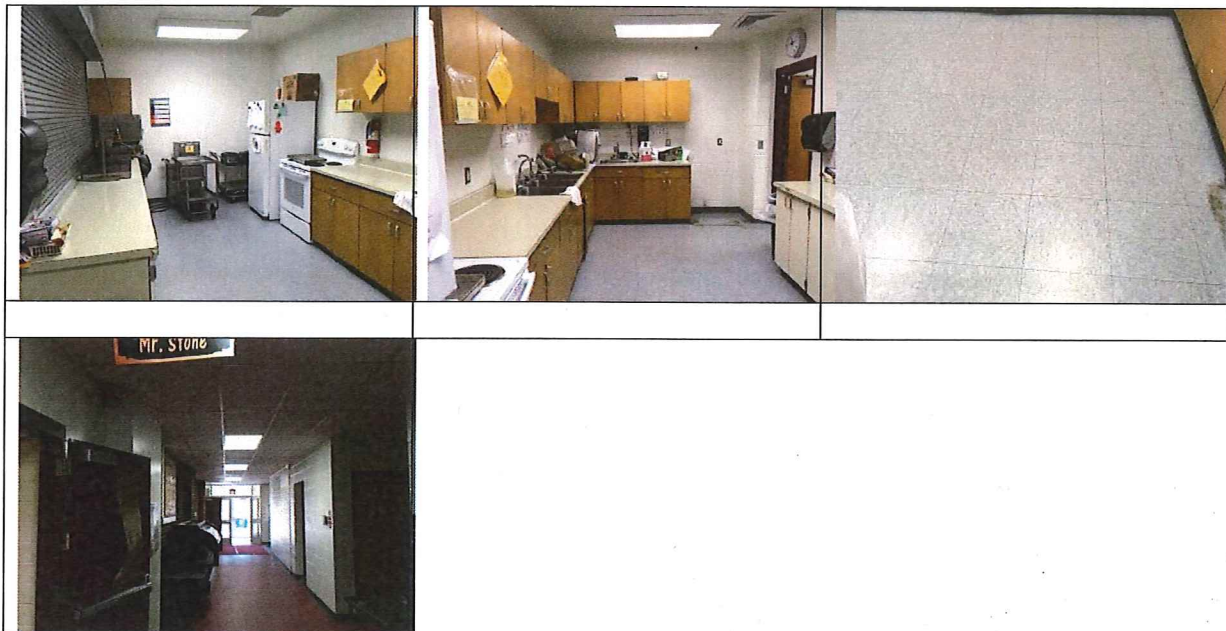
1. The kitchen is for warming and serving only. There is a single serving point through the East wall. Reconfiguring or relocation of the serving area should be considered to increase flow and efficiency.
2. The kitchen equipment appears to be in good condition.
3. The VCT floor is in good condition.
4. There is a residential stove/oven along with no exhaust hood.
5. Unable to verify a grease interceptor associated with the 3 compartment sink.
6. Casework is of a residential type, in poor condition.
7. The hard lid ceiling appears to be in good condition

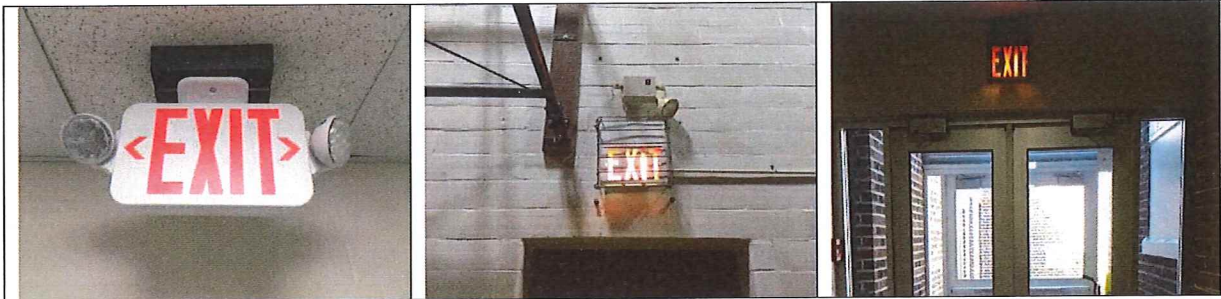
1. Emergency Lighting system
 - a. Emergency egress lighting appears to be supplied by integral light fixture battery packs. The lighting coverage should be evaluated with current code requirements along the path of egress. An electrical generator system could be considered as an alternative to battery packs for emergency power, potentially reducing maintenance and providing standby power.

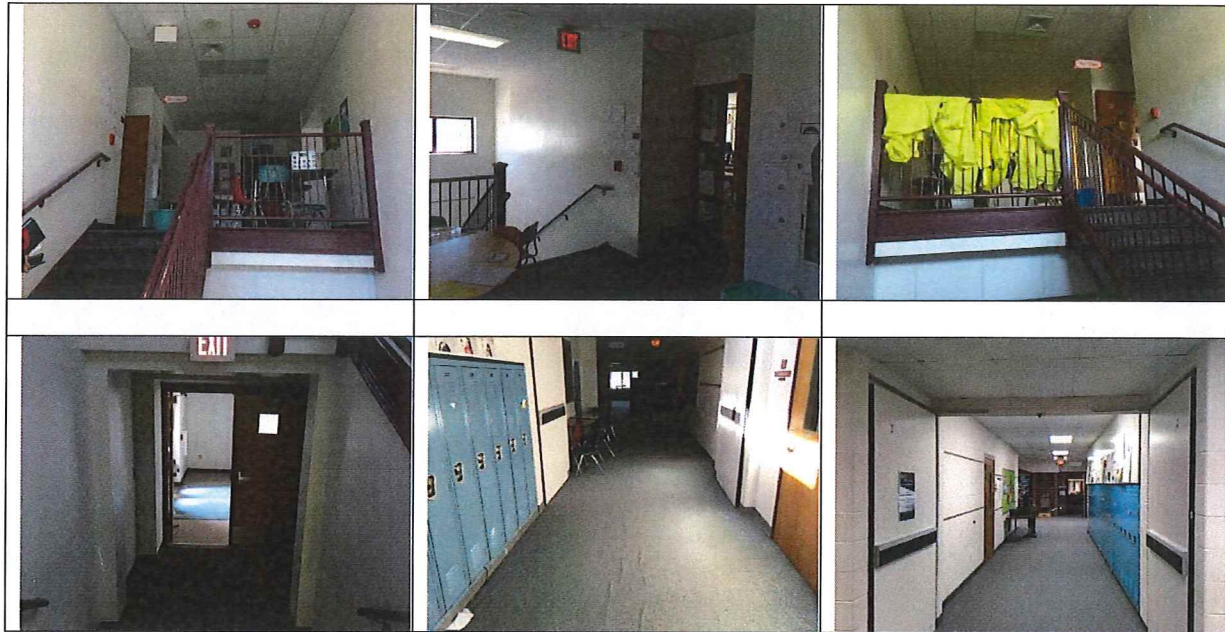
3. Building Components
 - a. The stairwell to the upper level does not meet the current requirements for fire separation. Considerable rework of the upper landing area and classroom entry is needed to bring this up to code.
 - b. The building does not appear to have a fire suppression system and is non-sprinkled.
 - c. The exit corridors have panic bars or crash bars that are in good condition.
 - d. The classroom windows have emergency egress.

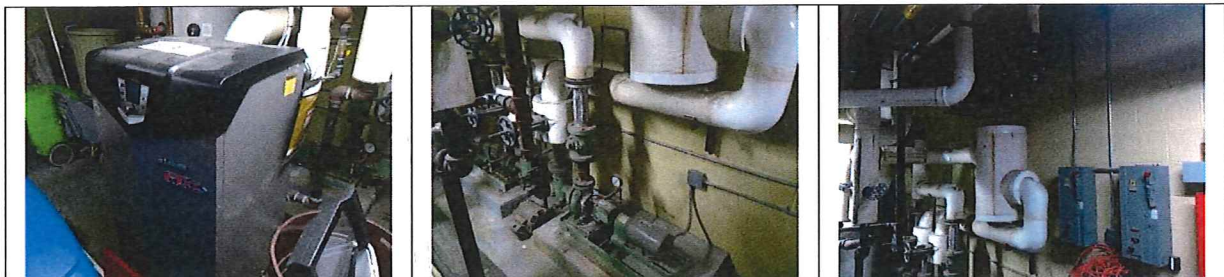
2. Central plant systems
 - a. New boilers (2015) in good condition.
 - b. Older pumps should be replaced with the addition of VFDs.
 - c. No central cooling in building.

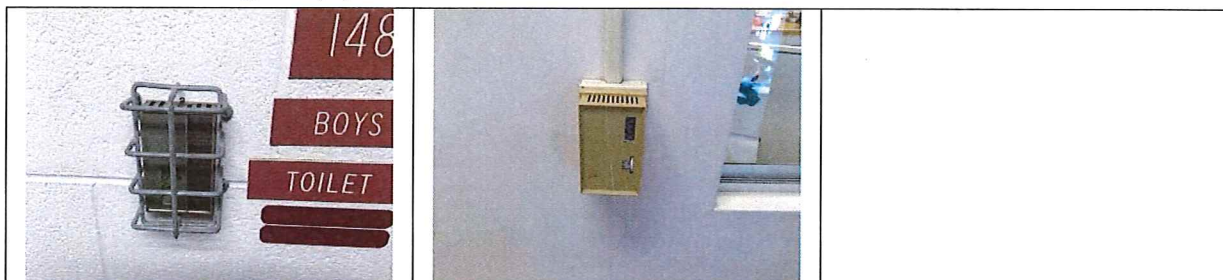
4. Building controls
 - a. Mix of sensor types throughout that are in fair condition. Update as necessary with new air handling units/systems to be installed.

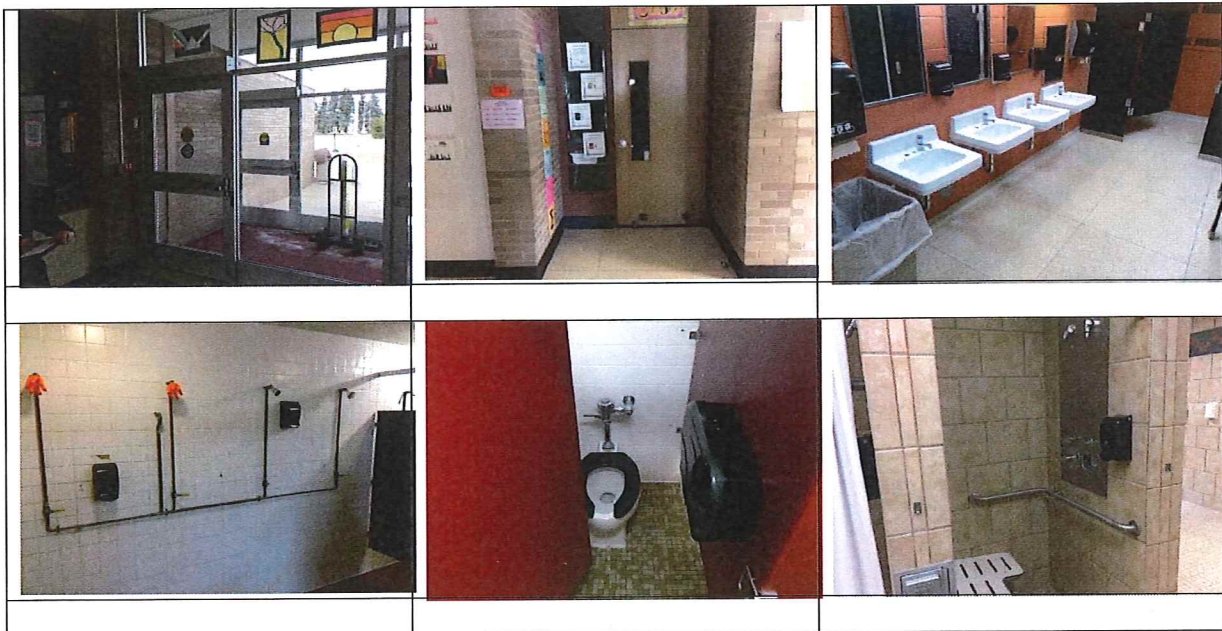
- f. Classroom sinks and hardware are compliant.
 - g. The ramp with-in the main corridor appears to exceed the ADA slope requirements.

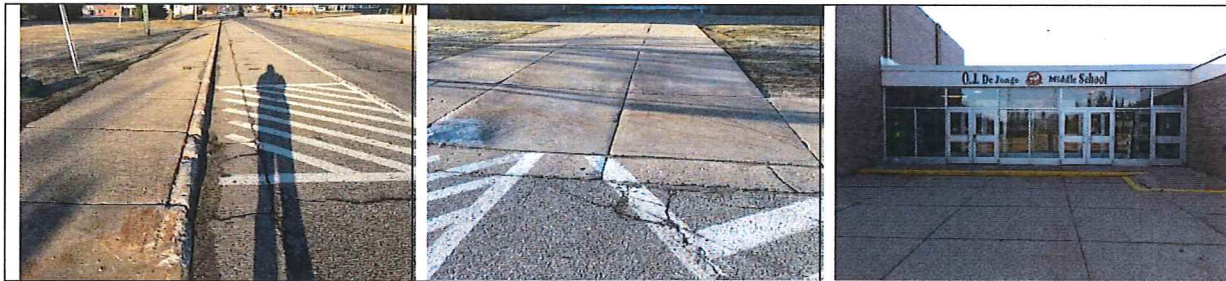
- a. There is no ADA parking near the main entry and it is not clearly defined.
- b. The closest marked ADA parking is on the East side of the building.
- c. No tactile warning strips noted at curb cut downs.
- d. The front entry stoop should be reworked to allow for an ADA landing near the door actuator.
