Franklin Elementary

Lakeview Elementary

Foster Elementary

Middle School

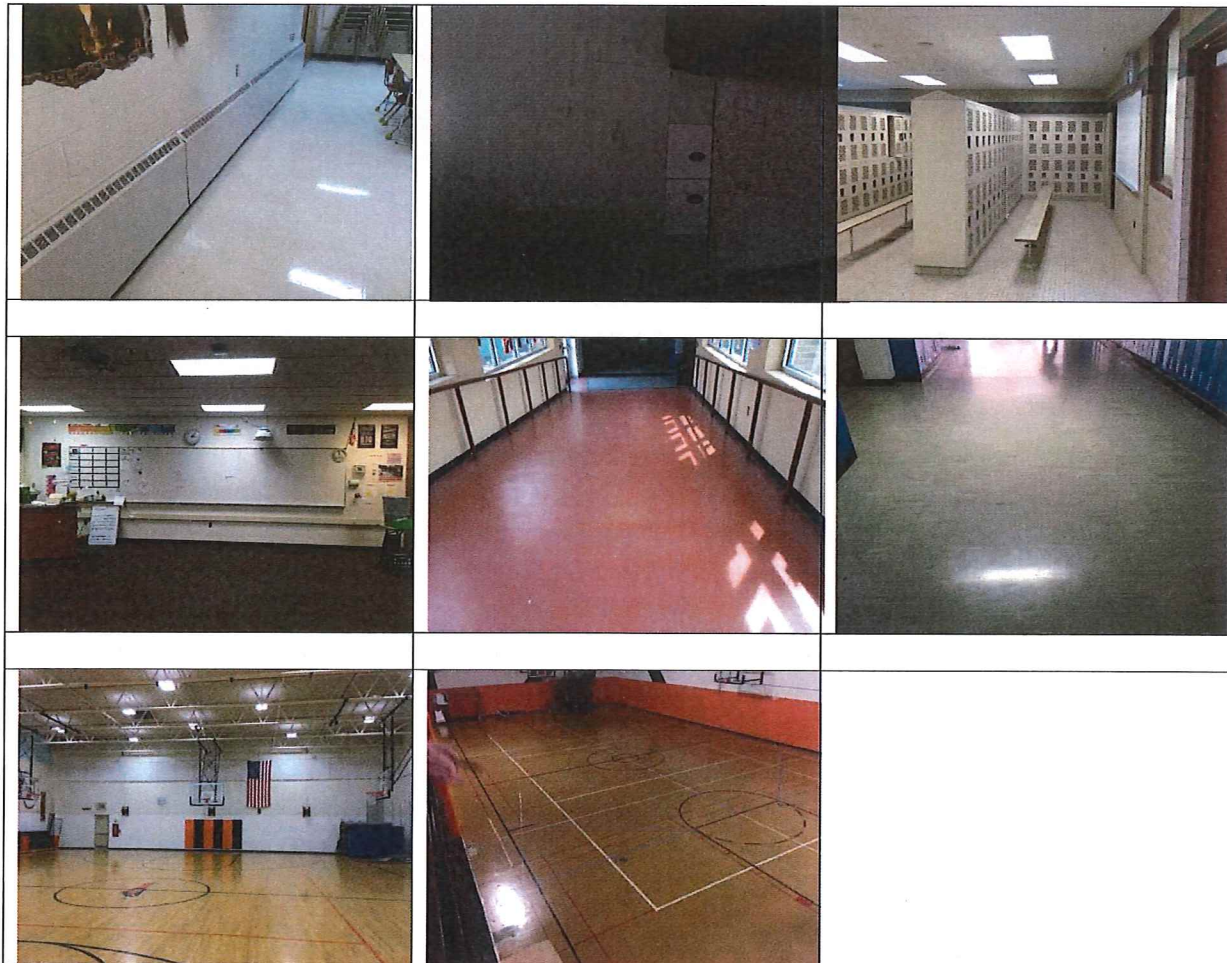
- i. There are various types and sizes of tile noted in the restrooms and shower areas.
- ii. The pool locker room flooring is in poor condition. Recommend to remove and replace as part of a locker room reconstruction.
- iii. Gymnasium locker room flooring is in good condition.
- iv. Single occupant staff restroom near offices in good condition.
- v. Quarry tile in the vestibules is in good condition.
- vi. The restrooms adjacent to the orchestra room are in fair to poor condition.

- i. The corridor ramps appear to have a luxury vinyl tile installed. They are in fair condition, with some substrate cracking showing through.

- i. There are several rooms that have 9x9 vinyl floor tile. This usually means it contains asbestos. Recommend it be removed and replaced with carpet. Roughly 40% of the classrooms contain this type of flooring.
- ii. The section of corridor between the ramp and auditorium corridor have 9x9 floor tile as well. Recommend it be removed and replaced with VCT to match classroom wing corridors.
- iii. The orchestral room is the 9x9 vinyl floor tile. Recommend it be removed and replaced.
- iv. Band practice rooms contain 9x9 vinyl floor tile.
