Franklin Elementary

Lakeview Elementary

Foster Elementary

Middle School

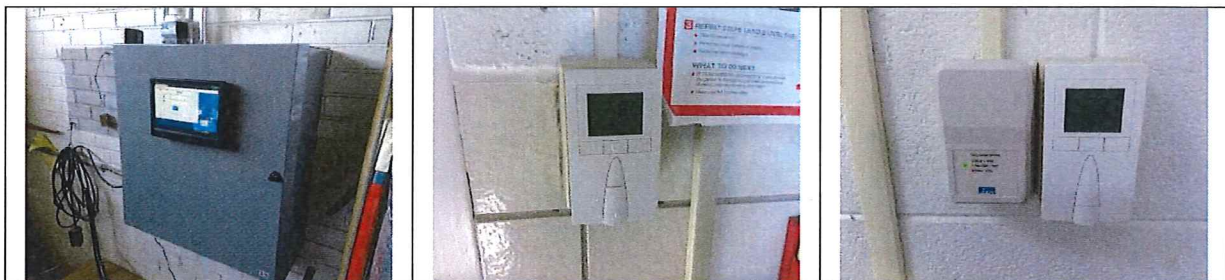
4. Building controls
 - a. Newer DDC system is installed in building with new sensors.

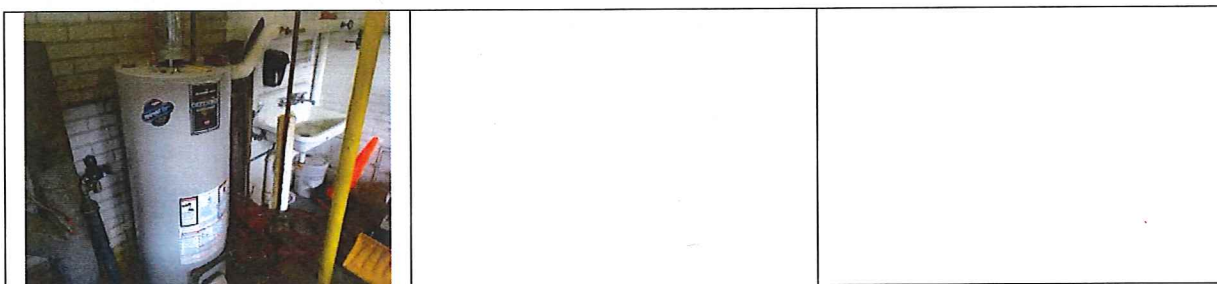
- a. Newer domestic water heater is in good condition.

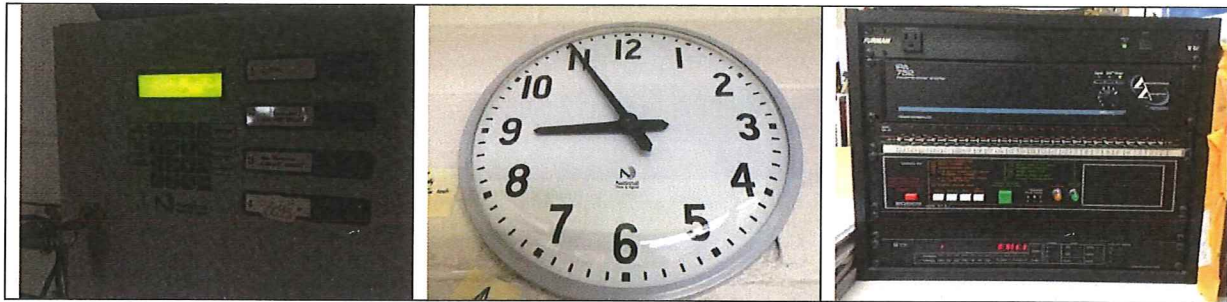
1. Technology infrastructure
 - a. The technology infrastructure appears to be newer and in good working condition. The supporting electrical infrastructure should be reviewed for redundancy and proper operation. An electrical generator system could also be considered for the technology closets for standby by power and providing emergency power.
2. Clock and PA systems
 - a. The clock and PA systems appear to be original to the building. This equipment appears in good working condition but is at the end of their life expectancy. Availability of replacement parts and required maintenance should also be considered.

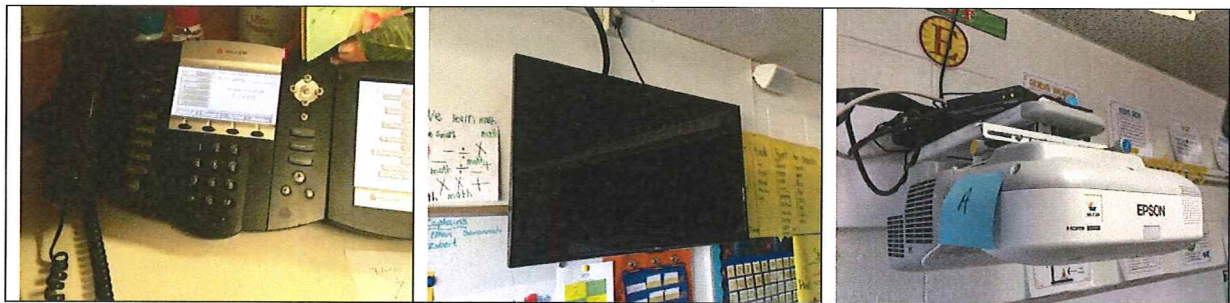
3. Classroom and communications technology
 - a. The technology devices and systems appear to be newer and in good working condition. These systems would be maintained or re-installed after renovation.

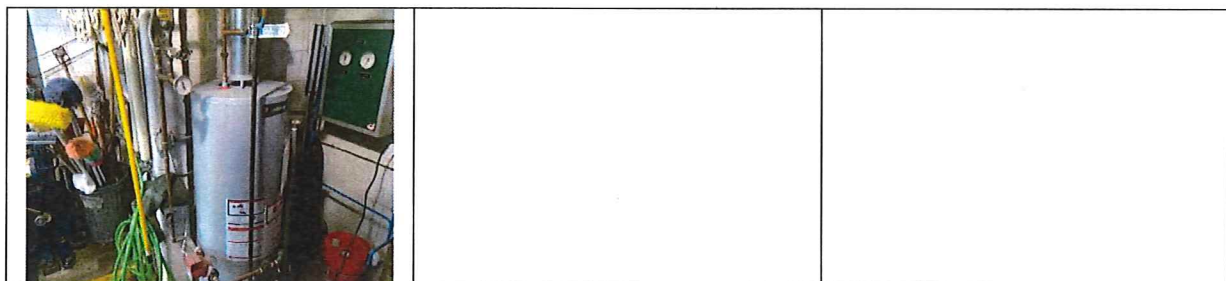
- a. Newer domestic water heater is in good condition.

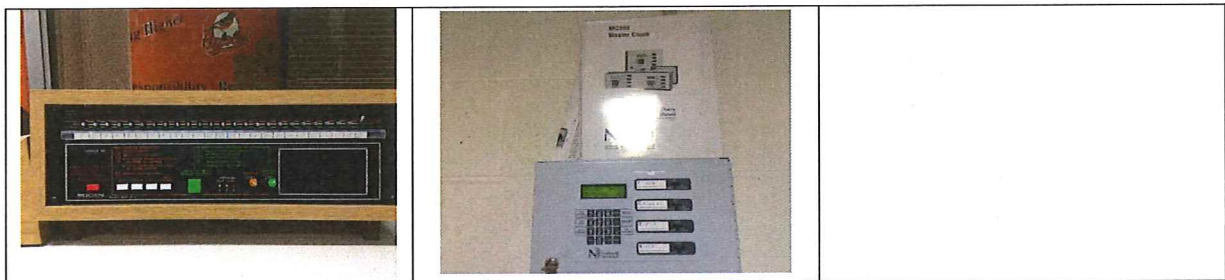
1. Technology infrastructure
 - a. The technology infrastructure appears to be newer and in good working condition. The supporting electrical infrastructure should be reviewed for redundancy and proper operation. An electrical generator system could also be considered for the technology closets for standby by power and providing emergency power.
2. Clocks and PA systems
 - a. The clock and PA systems appear to be original to the building. This equipment appears in good working condition but is at the end of their life expectancy. Availability of replacement parts and required maintenance should also be considered.

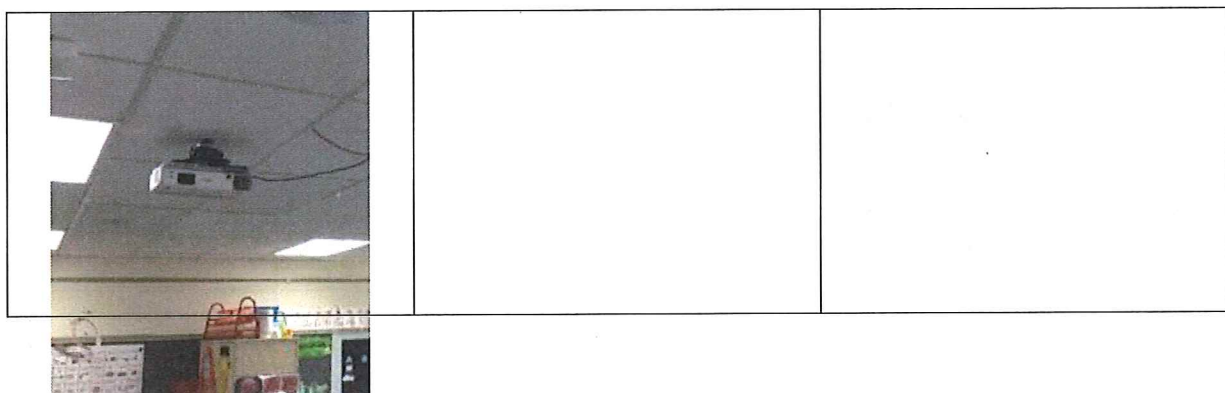
3. Classroom and communication technology
 - a. The technology devices and systems appear to be newer and in good working condition. These systems would be maintained or re-installed after renovation.

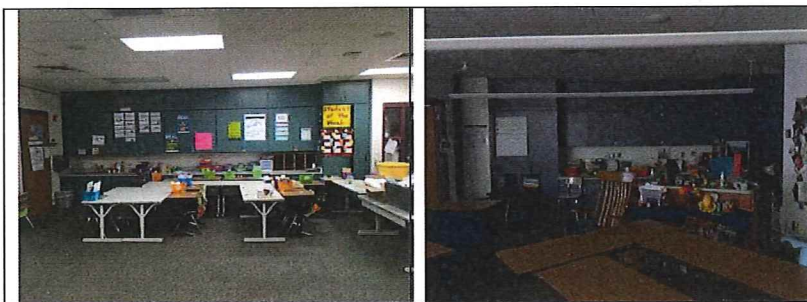
- a. The plastic laminate classroom casework is generally in good condition consisting of upper, lower and wardrobe cabinets, along with open shelving units.
- b. Sink bases appear to be ADA compliant.
- c. The quantity appeared to meet most of the teachers need for storage.

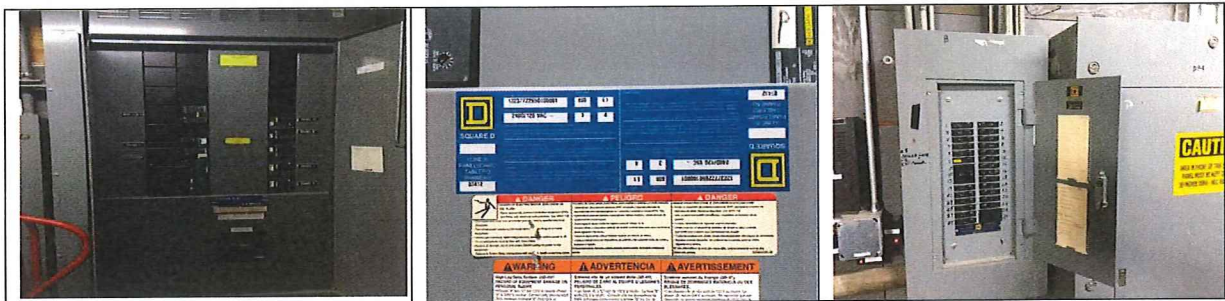
1. Electrical distribution system
 - a. Switchboards, panelboards and associated distribution equipment are newer and appear to be in good working condition.

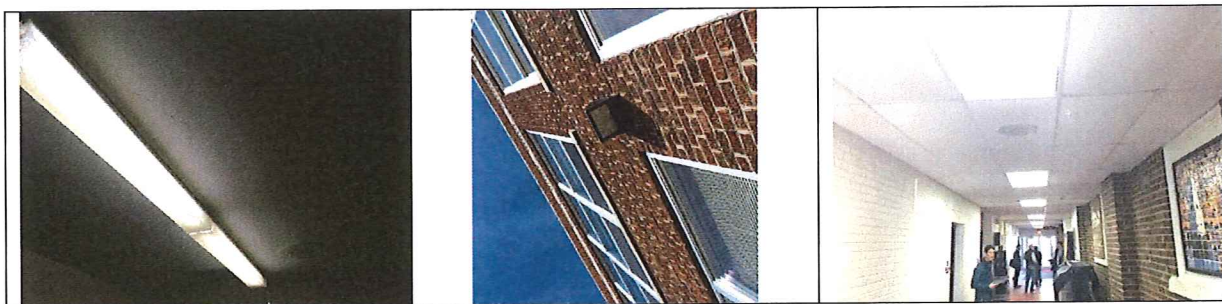
2. Lighting system
 - a. Interior lighting systems are predominantly T-8 fluorescent technology in the classrooms, corridors, offices and support spaces. T-8 fluorescent technology is reasonably efficient. A cost benefit analysis is recommended for T-8 fluorescent against LED lighting. For other fixtures types (including HID and T-12 fluorescent) it is recommended these be replaced with LED lighting.
 - b. Exterior and gym lighting systems are predominantly LED lighting. These light fixtures can be re-used in a renovation.

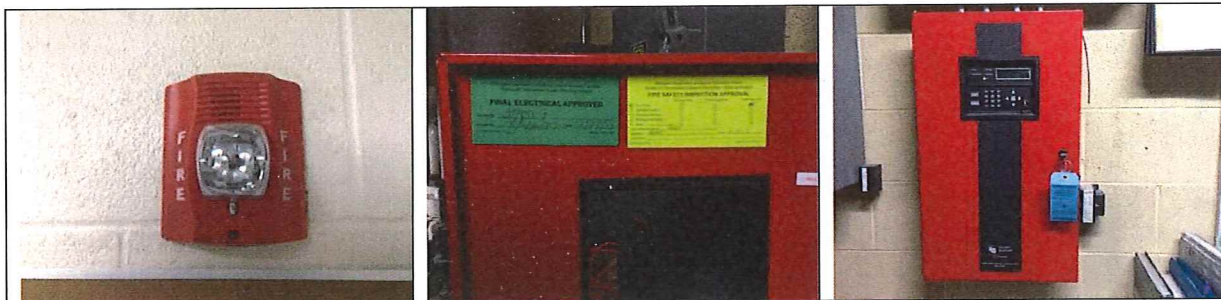
2. Fire Alarm system
 - a. The fire alarm system appears to be newer and could potentially be upgraded to become code compliant. New additions or remodeling will require voice evacuation to comply with current code.

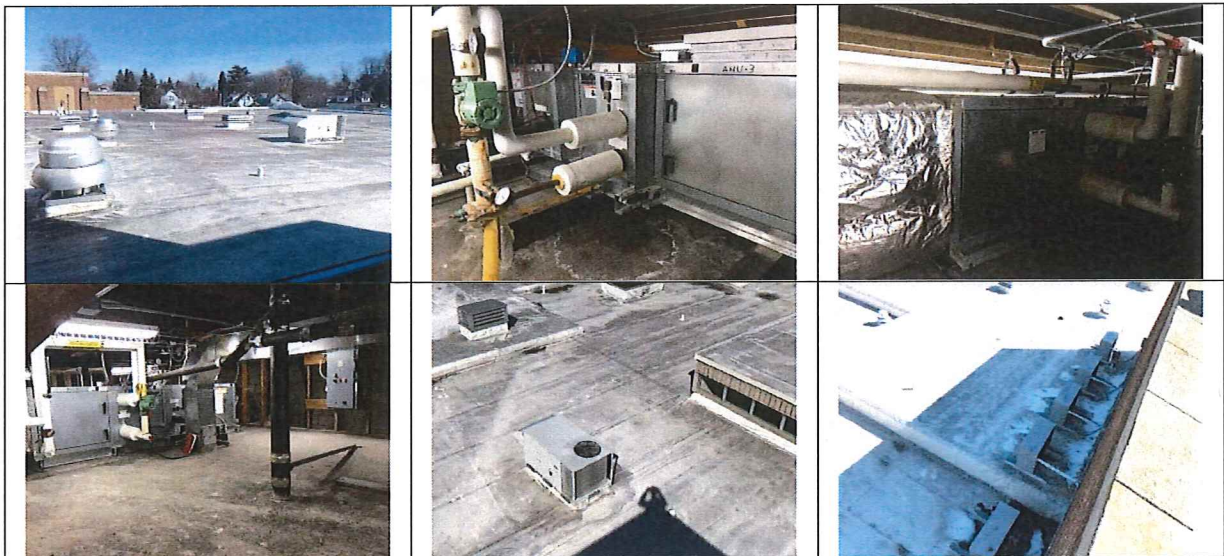
1. Air handling systems
 - a. Newer air handling units are located above the second floor and serve the South end.
 - b. Air handling unit located in penthouse for media center in good condition.
 - c. Various rooftop units and exhaust fans on roof are older but appear to be in fair condition.

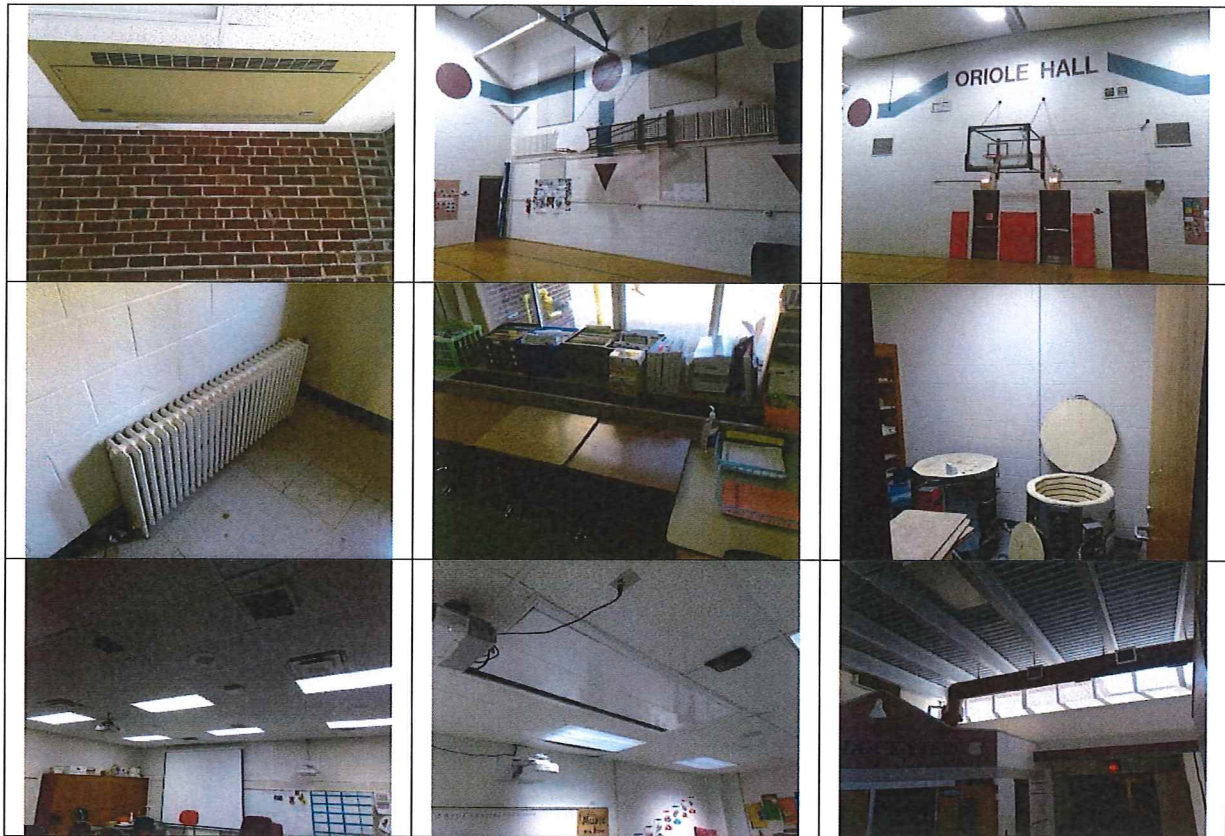
3. Terminal devices and air terminals
 - a. Cabinet heaters and horizontal unit ventilators throughout are older and in fair condition.
 - b. Consider replacing horizontal unit ventilators with vertical unit ventilators in classrooms and add cooling.

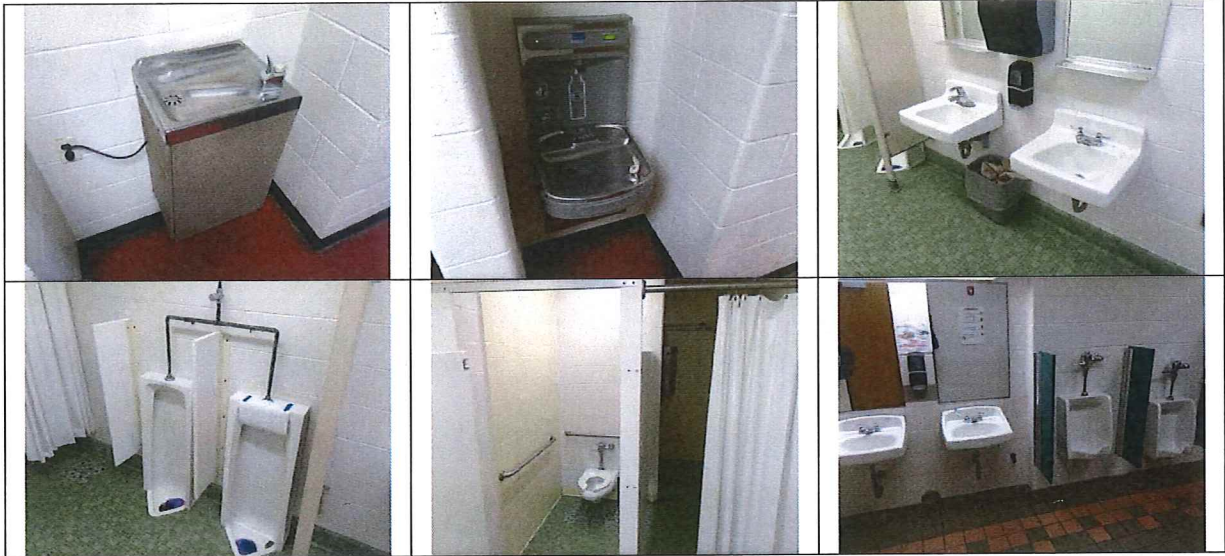
- a. Mix of plumbing fixture types and condition throughout. Older fixtures should be replaced.
- b. Manual flush valves.

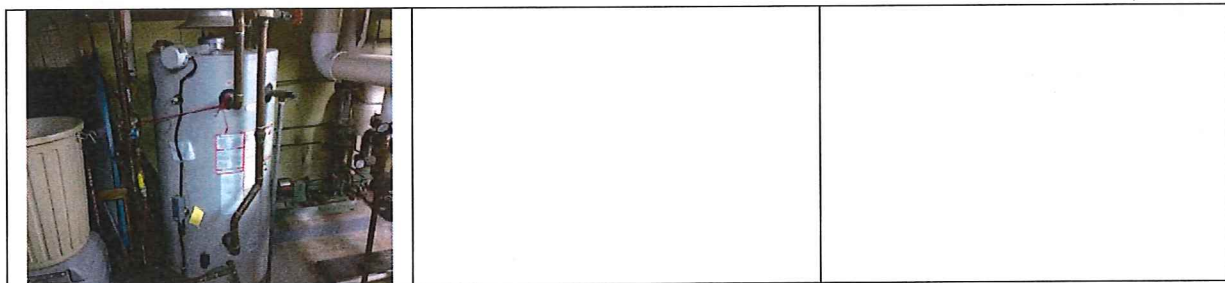
- a. Newer domestic water heater is in good condition.

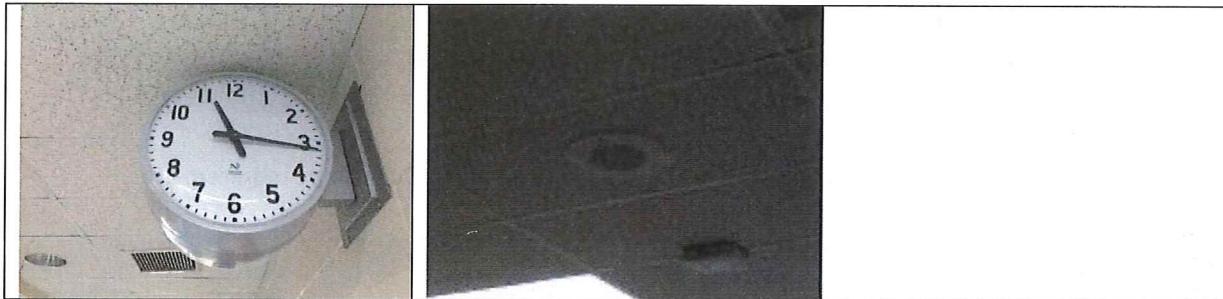
1. Technology infrastructure
 - a. The technology infrastructure appears to be newer and in good working condition. The supporting electrical infrastructure should be reviewed for redundancy and proper operation. An electrical generator system could also be considered for the technology closets for standby by power and providing emergency power.
2. Clock and PA systems
 - a. The clock and PA systems appear to be original to the building. This equipment appears in good working condition but is at the end of their life expectancy. Availability of replacement parts and required maintenance should also be considered.

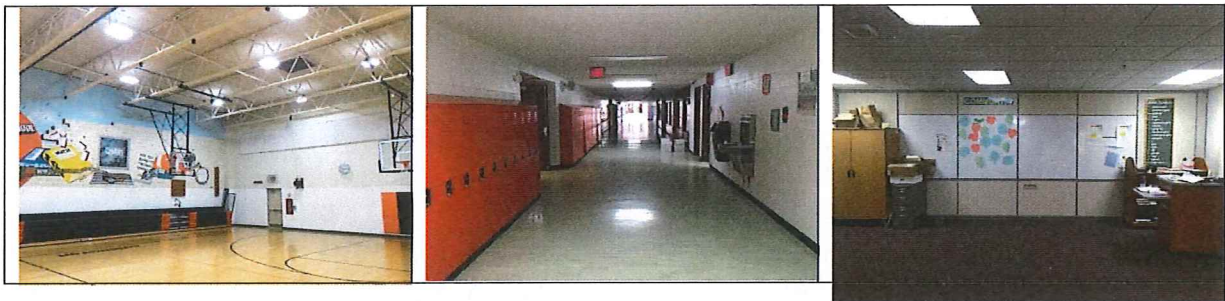
- a. The primary type of wall construction is painted CMU. This is generally in good condition.
- b. Exposed brick walls are in good condition.
- c. The moveable partition walls noted in several classrooms are in good condition.
- d. There is a minimal amount of gypsum board walls, those observed are in good condition.
